June 24, 2015

**Subject: Visual Clearance Inspection Report Paint Removal for IPWP1**

**Site Address:** 3100 Airport Way S  
Seattle WA

**NVL Project #:** 2012-494

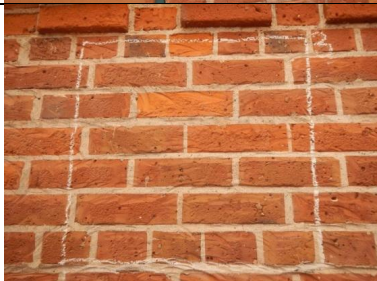
No
6	227

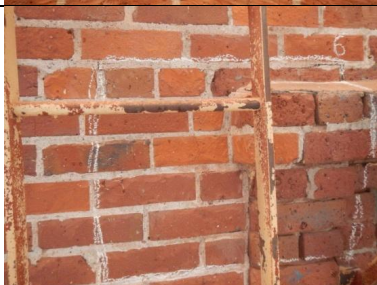
Yes- Red paint in mortar
7	280

Requirement 2 of Condition 7 of EPA's approval for IPWP1 states *"If paint remains after blasting is conducted additional remediation is necessary to meet the terms of this approval."* The Contractor was advised and additional remediation was carried out to satisfy the requirements of the Work.

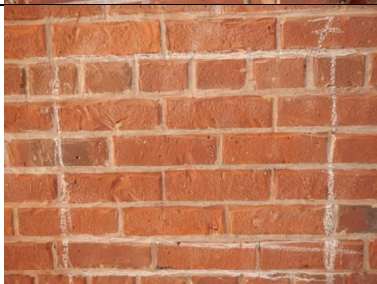
No
8	334

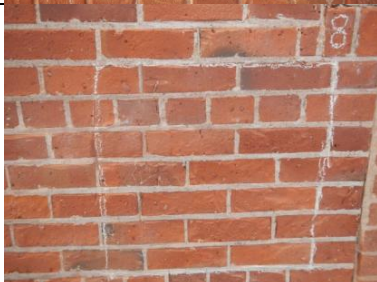
No

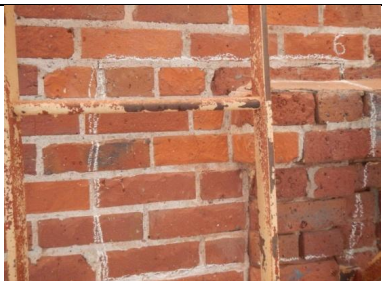
Random Count #	Grid #	Photo	Paint Still Present?
6	227

No

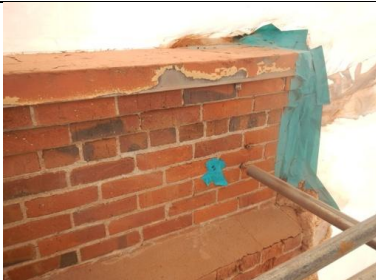
No <sup>2</sup>
10	80

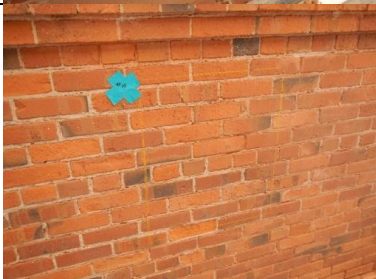
No
14	225	 	No
13	281	 	No
1	298

<sup>2</sup> Metal cap flashing remediated and disposed of separately from brick work.

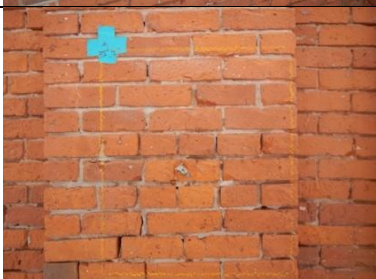
No

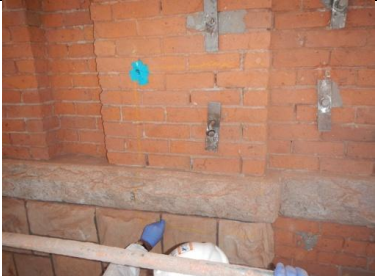
No
12	385

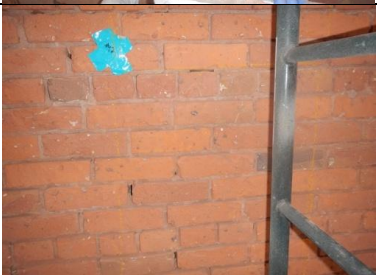
No
6	374
